Technical Service Bulletin

Chatter at takeoff may be caused by extreme driveshaft angle between the transmission and the differential.

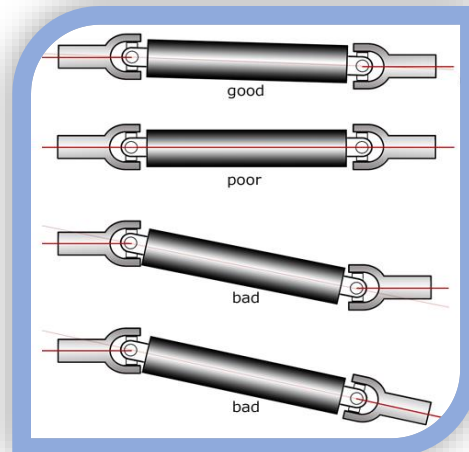
Driveshaft Alignment

- A. Input/Output angles equal, not excessive
- B. No angle, joints will not rotate.
- C. Excessive angle, joints will fail.
- D. Excessive, angles not equal
