Technical Service Bulletin

In 1990 1.9L Ford Escort applications, the release bearing cross shaft is supported by plastic bushings in the transaxle.

1990 Ford Escort 1.9L 116"

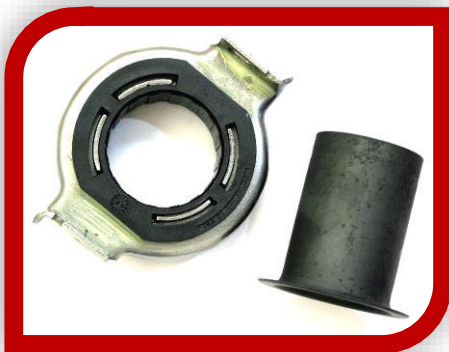
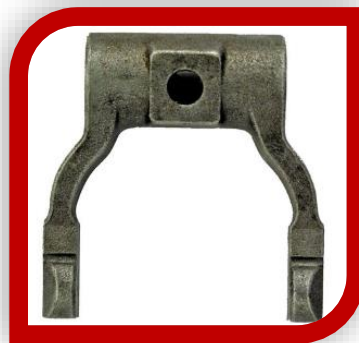
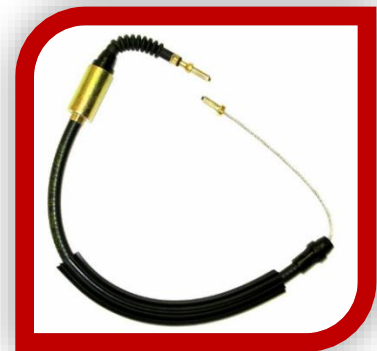
Bushing wear can cause a binding cross shaft and hard pedal, resulting in flexing and cracking of the firewall in the area of the cable.

- * Check the release system and all attachment points for damage.***
- * Always replace the bushings.***
