Technical Service Bulletin

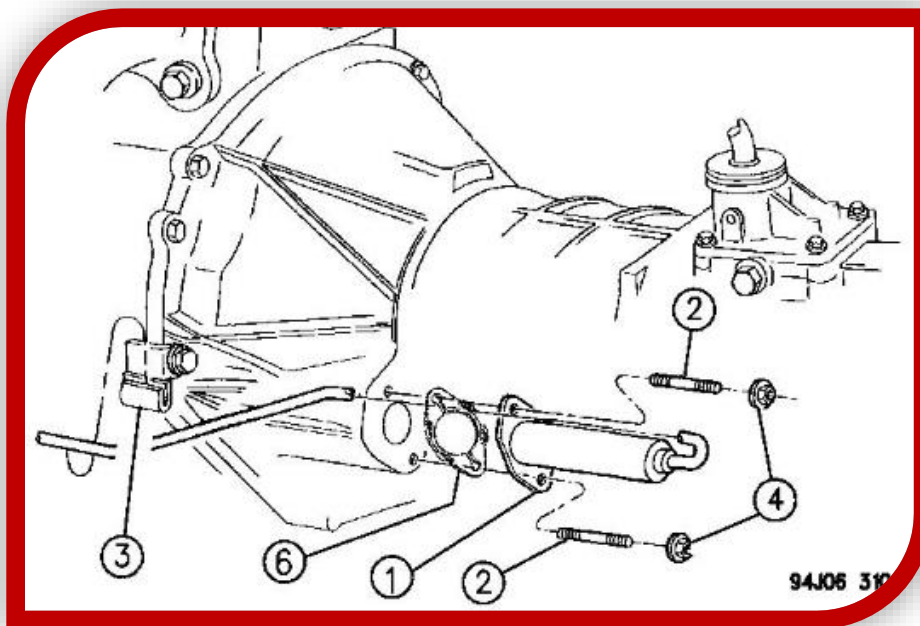
Premature clutch wear may be caused by insufficient clearance between the bell housing and slave cylinder. The slave mounting surface is located too far forward, restricting movement. This prevents proper fork movement, causing partial release and slippage.

Item 6 is Jeep shim 4797072

Install a shim, Jeep part #4797072, between the slave cylinder and bell housing to avoid premature wear.
