## Technical Service Bulletin

### Hard Pedal Concerns

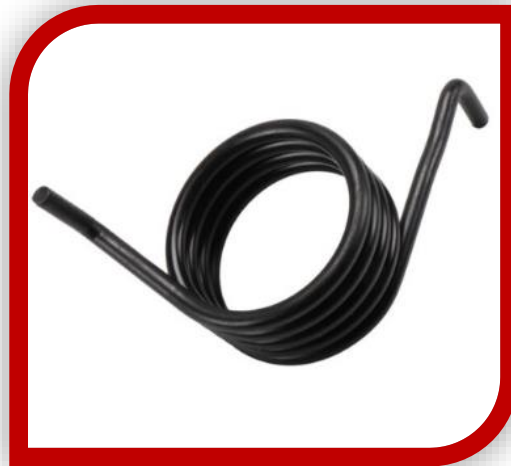
*GM Clutch Pedal Return Spring*

1985-1994 Chevrolet/GMC C/K, G, R and S/T Series, Blazer, Jimmy, Sonoma Hard pedal and scraping noise while actuating the clutch pedal may be caused by failure of the clutch pedal return spring.

Remove the return spring. It is not needed for proper operation.
