Technical Service Bulletin

Noise and Premature Clutch Wear

Year	Make	Model	Engine
2002-04	Ford	Focus	4 cyl 2.0L 121" SVT 6-Speed DOHC

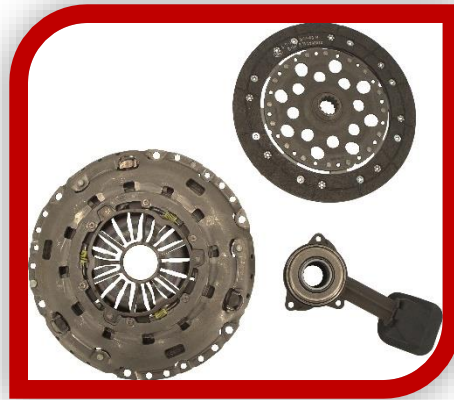
PDL Kit 07-175

Referenced applications may exhibit signs of premature clutch wear or produce a clunk or rattle noise while the vehicle is in neutral and the clutch pedal is disengaged. The noise diminishes when the pedal is actuated. These problems may be caused by alignment issues in the clutch, disc, dual-mass flywheel or transaxle.

Install a complete clutch set, which includes a revised clutch, disc and dual-mass flywheel. You must install all of the new components because they are incompatible with those in the vehicle.

Torque all bolts in a star pattern to these specifications:

- Flywheel mounting bolts 83 ft-lb
- Clutch mounting bolts 21 ft-lb
- Transaxle mounting bolts 35 ft-lb
