Technical Service Bulletin

Pedal Vibration and Noise after Clutch Installation

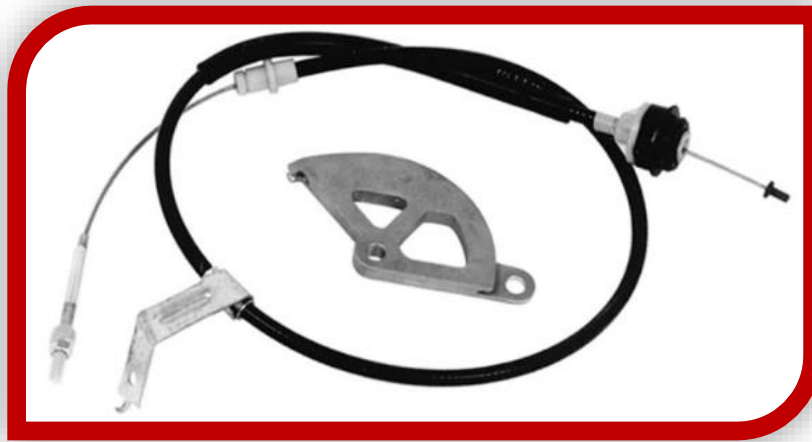
PDL 21765 (M-7553-E302 Cable & M-7583-A Quadrant)

Some vehicles may exhibit a rattle, chirp, squeak, and or pedal vibration after a new clutch is installed. Insufficient pre-load on the release bearing may be the cause.

The original self adjusting cable and plastic quadrant are known to wear and fail over time. The correction is to replace the cable and quadrant with a new upgraded, adjustable cable and all aluminum quadrant. This will allow for proper release bearing pre-load to be set.

Installation of new cable and quadrant:

1. Remove the old cable from the plastic quadrant and from the transmission.
2. Remove the three cotter pins or hitch pins and washers from the quadrant and ratcheting paw assembly. Keep the pins and washers for use during reinstallation.
3. With the pins removed, slide the plastic quadrant and ratcheting paw off the mounting studs. On some models the ratcheting paw assembly may have to be cut in half to remove due to the heater box being in the way.
4. Install new aluminum quadrant onto pedal assembly by sliding onto the studs.
5. Install the washers and the pins onto the studs.
6. Install the new cable assembly onto the quadrant.
7. Install the cable onto the clutch fork and adjust the cable to proper pre-load.
8. After test driving the vehicle recheck for proper cable adjustment.
