Technical Service Bulletin

Clutch Pedal Noises

Some 2005 – 2023 model year Tacoma vehicles equipped with a manual transmission may exhibit a squeak or creak noise from the clutch pedal when it is depressed or released.

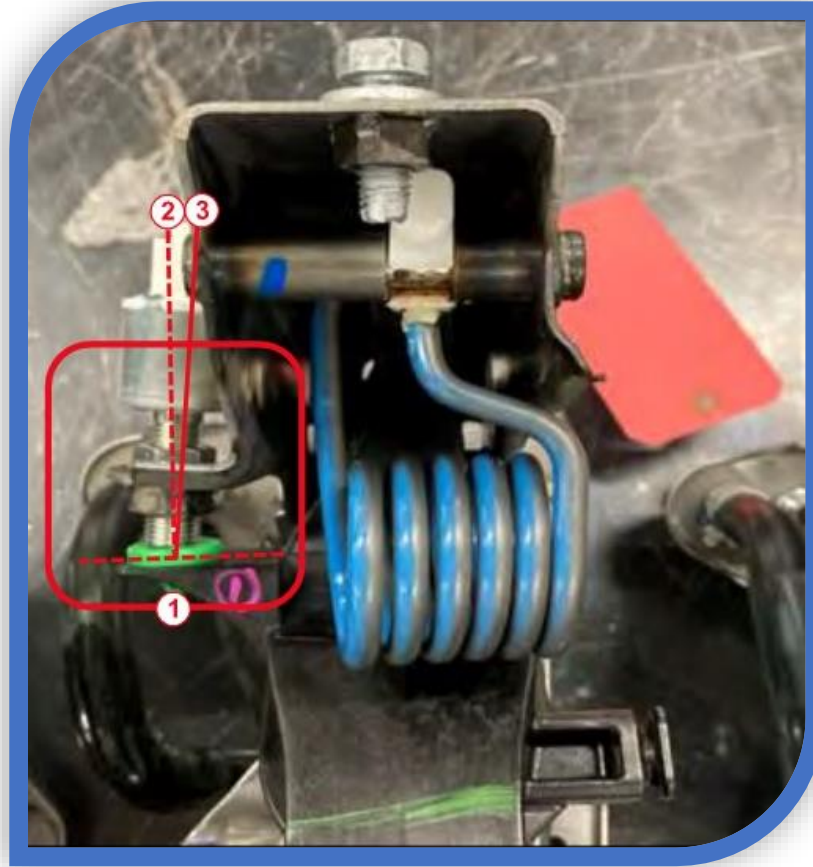
1	Deformation Area
2	Normal Position
3	Position After Deformation

- 3. Inspect the clutch pedal bracket assembly for ANY deformations. Replace the clutch pedal bracket if necessary**
