Technical Service Bulletin

Clutch Pedal Noises

MC0822 (46920-S7A-A04)

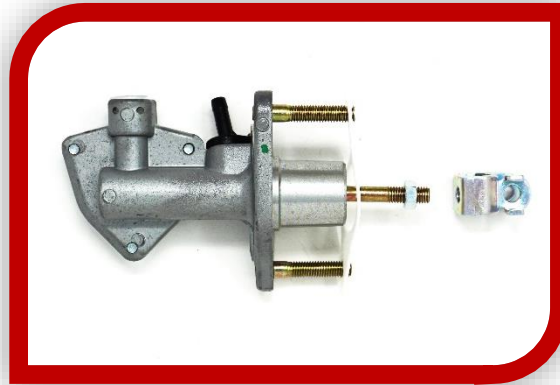
Customer may experience a popping, squeaking, or clicking noise when depressing or releasing the clutch pedal. Noise is typically most noticeable at the initial movement of the pedal or during return.

This condition is commonly caused by insufficient internal clearance between the clutch master cylinder piston and the push rod. When proper clearance is not maintained, the piston does not move smoothly within the bore, resulting in intermittent noise during operation. Over time, this can also contribute to inconsistent pedal feel and premature wear of internal sealing components. Replace the clutch master cylinder assembly with the updated design to correct this concern.

- Ensure proper pedal free play is set according to OE specifications after installation
- Verify push rod alignment and engagement during installation
- Inspect related components (pedal bushings, clevis pin, and return spring) to rule out secondary noise sources

Once the updated clutch master cylinder is installed and properly adjusted, the pedal should operate smoothly and quietly with no popping, squeaking, or clicking noises present.
