Technical Service Bulletin

When installing a Volkswagen pull-type clutch with a release plate and wire ring, cycle the clutch prior to start up to ensure the circlip is fully seated under the tabs of the diaphragm spring. If the clutch set contains a release bearing, you **must** install it.

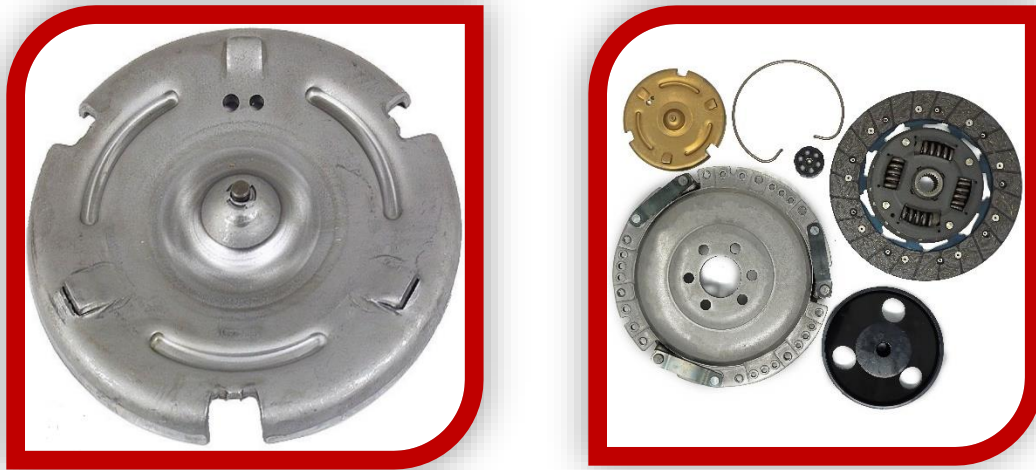
The bearing fits inside the transmission. The clutch release arm presses against the bearing to move a long rod passing through the transmission. The rod pushes the release plate to push the diaphragm fingers and disengage the clutch.

A sheet metal cover must be pried out for access to the release bearing. This typically results in the destruction of the cover, which must be replaced to prevent transmission oil leaks.

Also inspect the release rod for wear or bending, the lever for cracks, and the shaft for spline damage.
