TECHNICAL BULLETIN

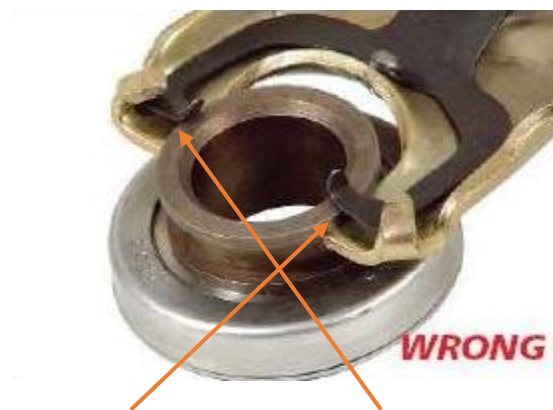
Figure 1

Retaining clip on the outside of bearing

Incorrect installation of the most popular GM and Ford release bearings (N083SA, N1714SA, N1716, N1716SA) is a leading cause of warranty claims. Before installing your newly purchased clutch kit, please note the following illustrations and the correct installation of the retaining clips to the release bearing. The retaining clip **MUST BE** on the inside (figure 2) of the release bearing to avoid damage and nullifying any warranty.

WARNING: *Any warranty will not be honored on any associated parts if the release bearing shows any evidence of marks, gouges or notching on the release bearing collar from the fork retaining clips not being installed correctly under the release bearing collar.*

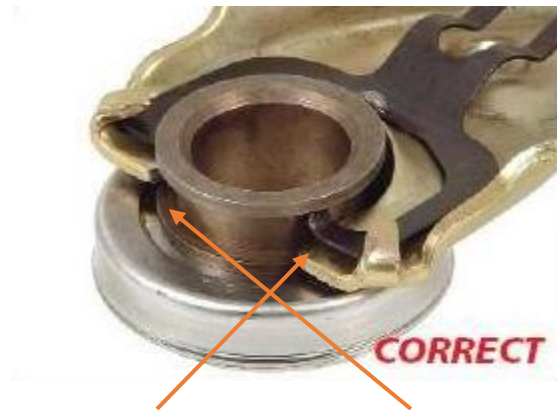
Figure 2

Retaining clip on the inside of bearing
