Technical Service Bulletin

Diagnosing Slipping and Chatter

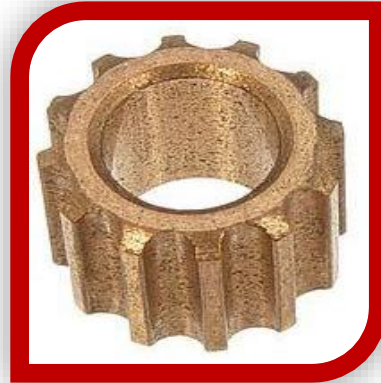
Slipping or chattering conditions result from oil contamination of the disc friction material. The clutch push oil seal (VW part #020311108A) is often the source of the oil leak. Also inspect the push rod seal, the rear main engine seal and the transmission input shaft seals.

Replace the push rod bushing (VW part #020311107C) with a pushrod seal.
