Technical Service Bulletin

Items Affected: Self Adjusting Clutch Covers

Concern: No release condition

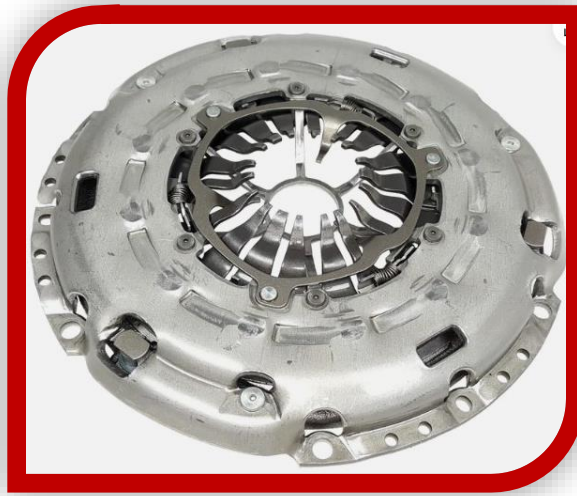
The locking mechanism located within the diaphragm spring on the affected covers, should not be removed until after the clutch is securely mounted to the flywheel to ensure proper engagement once set.
