## Technical Service Bulletin

Year	Make	Model	Engine
1988-1993	Toyota	Pickup	6 Cyl 3.0L 2954cc

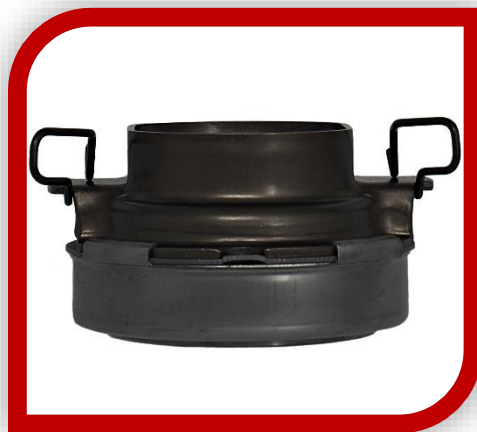
**PDL N807**

- You will hear chirping, which gets louder when you slowly depress the pedal, if it's the **release bearing**.
- You will hear squealing when you actuate and hold the pedal, if it's the **pilot bearing**.

If the noise stops after approximately five minutes, replace the slave cylinder.  
If the noise continues after the vehicle is warm, the cause is probably the release bearing and/or the pilot bearing.
