## Technical Bulletin

Incorrect installation of the most popular GM and Ford release bearings is a leading cause of warranty claims. Before installing your newly purchased clutch kit, please note the following illustrations and the correct installation of the retaining clips to the release bearing. The retaining clip **MUST BE** on the inside (figure 2) of the release bearing to avoid damage and nullifying any warranty.

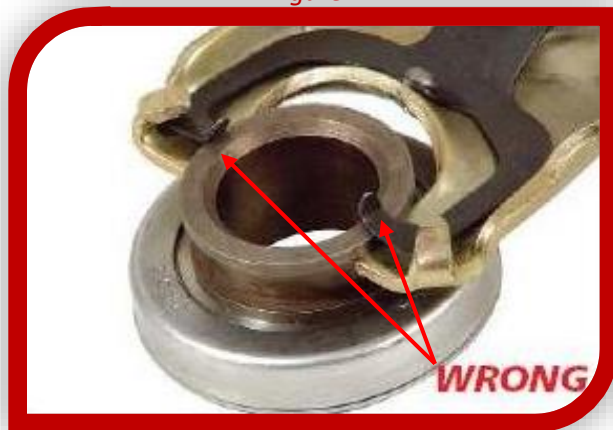
*Figure 1*

*Retaining clip on the outside of bearing*

***WARNING:*** *Warranty will not be honored on any associated parts if the release bearing shows any evidence of marks, gouges or notching on the release bearing collar from the fork retaining clips not being installed correctly under the release bearing collar.*

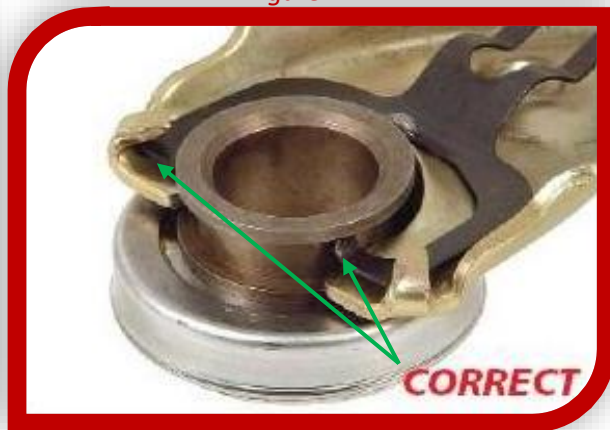
*Figure 2*

*Retaining clip on the inside of bearing*
